THE ADANA -CEYHAN EARTHQUAKE of JUNE 27, 1998

Oğuz Gündoğdu¹, Naşide Özer², Melih Baki³

INTERNATIONAL WORKSHOP ON
RECENT EARTHQUAKES AND DISASTER PREVENTION
MANAGEMENT
10-12 MARCH 1999
Middle East Technical University
Convention and Cultural Center Ankara Turkey

RAPOR NO: METU/DMC 99-02

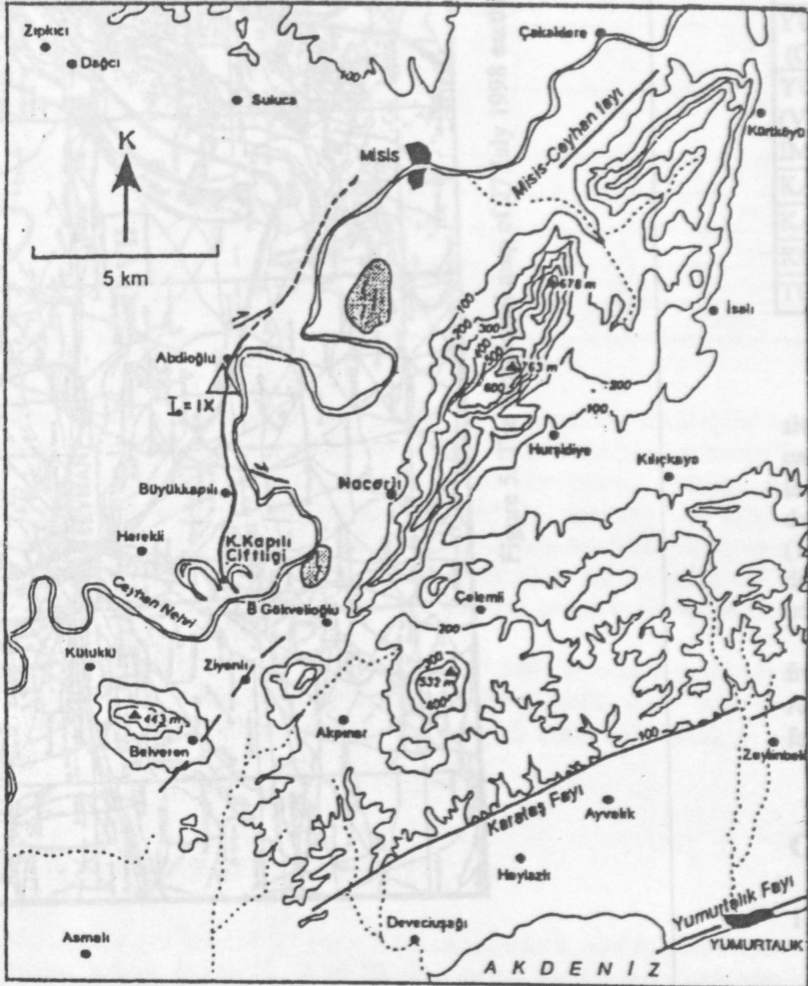
Source of faulting is in Çukurova Basin and the fault occurred with this earthquake could not continuously traced in the field due to relatively great thickness of alluvial deposits and source depth. Faulting could be observed with the indications of tension cracks, sandblowings and etc. Faulting traced from southern Abdioğlu Village at North to Yeni Küçükkapılı farm at South (Figure 4). In front of Kazime Özler Primary School, 7cm offset is measured. Although some researchers previously mentioned that faulting is at Misis Fault or Karataş Fault but, we had not observed any indication or

movement at those faults (Barka, 1998). We also observed a trace near the Ceyhan River towards to Nacarli.

Figure 4 : Faulting occurred by Adana-Ceyhan earthquake. Δ shows the macroseismic epicenter.

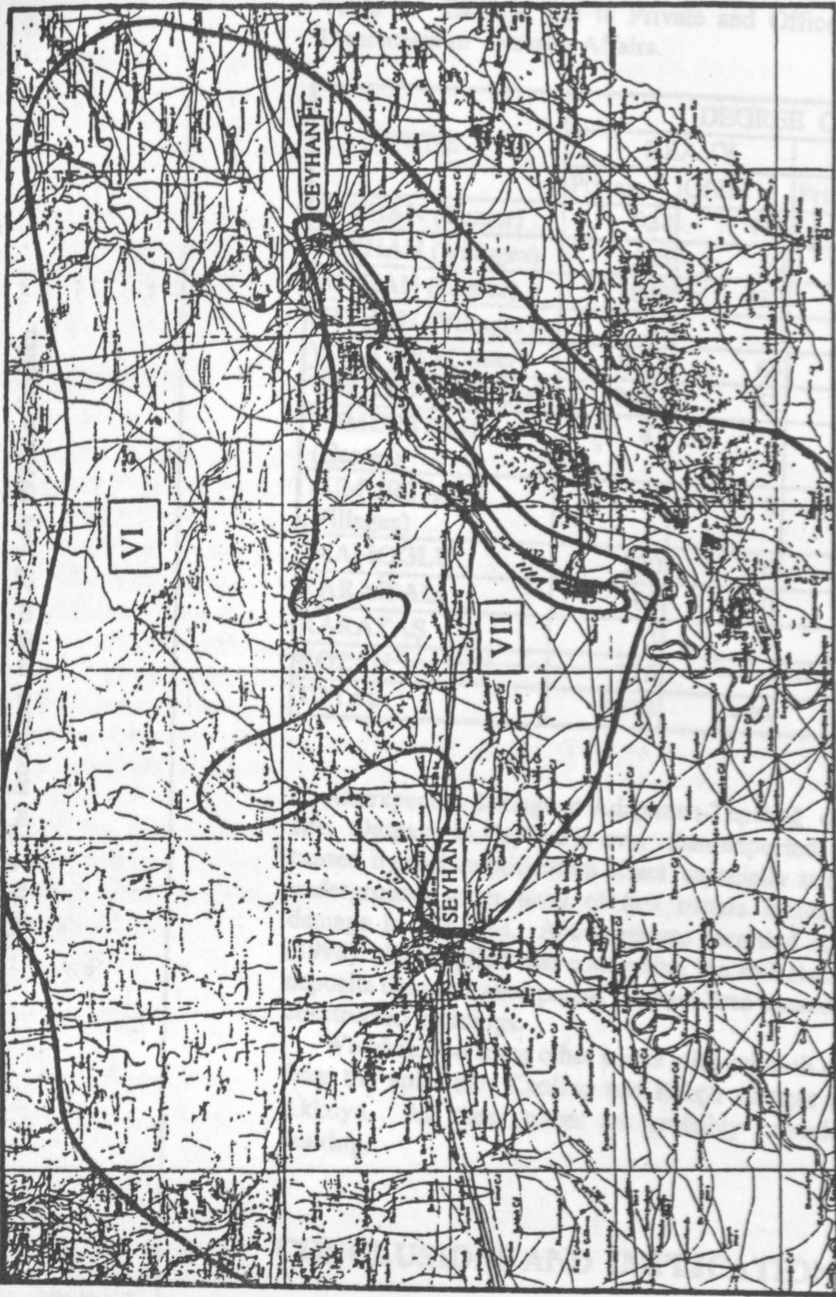
The izoseismal map prepared after observations in the field, structures and 150 questionnaires and personal communications with the people at 72 villages and towns (Figure 5). Based on the sandblowings observed through the Ceyhan river and the acceleration value of 273.6 cm/sec^2 in the E-W direction in Ceyhan, the maximum intensity of this earthquake is decided as $I_0 = IX$ (MSK). 145 people were killed and over a thousand injured by this earthquake. According to the preliminary determination of General Directorate of Disaster Affairs, 9878 Private Residences(PR) and 490 Office Residences(OR) were heavy, 18094 PR and 1284 OR moderate, and 46968 PR, and 3009 OR slight damaged (Table 2).

Figure 5: The isoseismal map of 27 July 1998 earthquake.

Unexpected damage at Adapazarı-Tepebağ due to dense historical buildings in this site. Damage in Ceyhan is over than expected. Severe damage in concrete buildings caused by soil amplification effect especially at Hasevler district. Alluvial deposit and underground water level of few meters increased the intensity and caused severe damage in this area. Acceleograms recorded at Ceyhan are interpreted by Eyidoğan (1998). He implied that concerning the soil classification and the thickness of aluvial deposits the resonance period is about 3sec caused the damage to higher and improperly constructed buildings.
